DEPARTMENT OF TRANSPORTATION

Quality Assurance and Source Inspection

Contract #: 04-0120F4Cty: SF/ALA Rte: 80 PM: 13.2/13.9File #: 1.28**WELDING INSPECTION REPORT****Resident Engineer:** Casey, William**Address:** 333 Burma Road**City:** Oakland, CA 94607**Report No:** WIR-027837**Date Inspected:** 22-Jun-2012**Project Name:** SAS Superstructure**OSM Arrival Time:** 700**Prime Contractor:** American Bridge/Fluor Enterprises, a JV**OSM Departure Time:** 1930**Contractor:** American Bridge/Fluor Enterprises, a JV**Location:** Job site**CWI Name:** As Noted Below**CWI Present:** Yes No**Inspected CWI report:** Yes No N/A**Rod Oven in Use:** Yes No N/A**Electrode to specification:** Yes No N/A**Weld Procedures Followed:** Yes No N/A**Qualified Welders:** Yes No N/A**Verified Joint Fit-up:** Yes No N/A**Approved Drawings:** Yes No N/A**Approved WPS:** Yes No N/A**Delayed / Cancelled:** Yes No N/A**Bridge No:** 34-0006**Component:** OBG/Tower**Summary of Items Observed:**

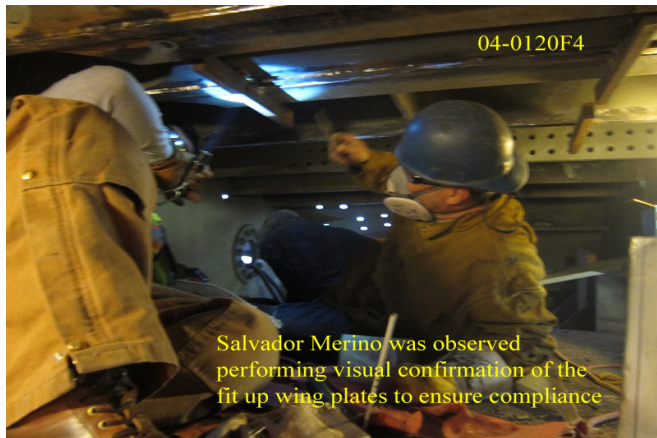
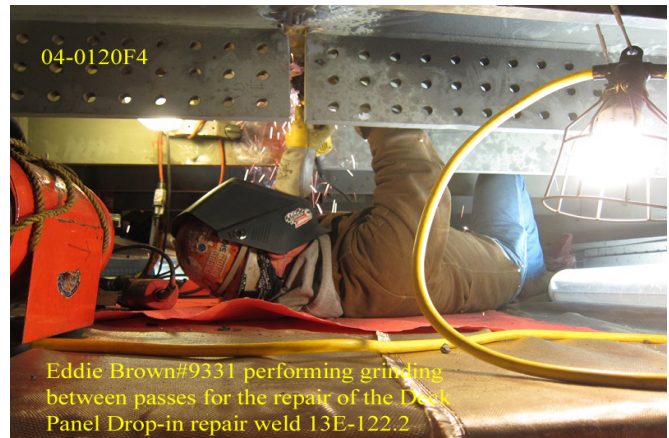
The QA inspector observed at random intervals, ABF/JV qualified welder Richard Garcia # 5892 performing fit up of the wing plate assemblies for the longitudinal stiffener LS2 between panel point 124.5 and 125. The ABF Quality Control (QC) inspector Salvador Merino was observed performing visual confirmation of the fit up wing plates to ensure compliance.

The ABF/JV qualified welder Richard Garcia #5892 was observed later in the shift performing Shielded Metal Arc Welding (SMAW) in the 4G position utilizing the Caltrans approved Welding Procedure Specification ABF-WPS-D1.5-1162-4. The welding observed was for the HPS-485 longitudinal stiffener wing plate partial joint penetration (PJP) weld connections located between panel points 124.5 and 125 at LS2. The weld surface and surrounding area was brought to temperature by the use of induction heaters and the preheat temperature was confirmed ABF personnel prior to welding. The Quality Control (QC) inspector Salvador Merino was observed monitoring the welding parameters at the start of welding. The root pass of the weld was observed to be completed prior to the end of the QA inspectors shift and requires magnetic particle testing prior to the deposit of additional layers.

ABF-WPS-D1.5-1004. The welding observed was for the repair of the deck panel drop-in splice weld as previously rejected by Ultrasonic Testing (UT). The repair surface and surrounding area was brought to temperature by the use of induction heaters placed on the topside of the deck. The preheat temperature was confirmed ABF personnel prior to welding. The weld is located between panel points 122~122.5 and is designated as 13E-122.2. The weld repairs observed were completed at the following locations in the above mentioned weld prior to the end of the QA inspectors shift.
